## FORD POWER STROKE 6.0L

### Part 1: What Fails and Why

**2.** This is our project truck, an '03 F-350 4x4 dualy. The rig didn't have a whole lot of miles, but judging by the mud under the body, it had seen some hard use. Once in the Banks workshop, the first challenge was just to get at the engine.

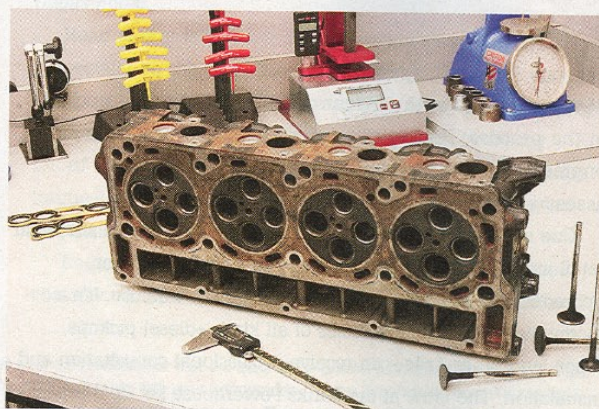
**10.** The heads on the 6.0 are cast iron; these were a little bit corroded, but they had not warped significantly or cracked.

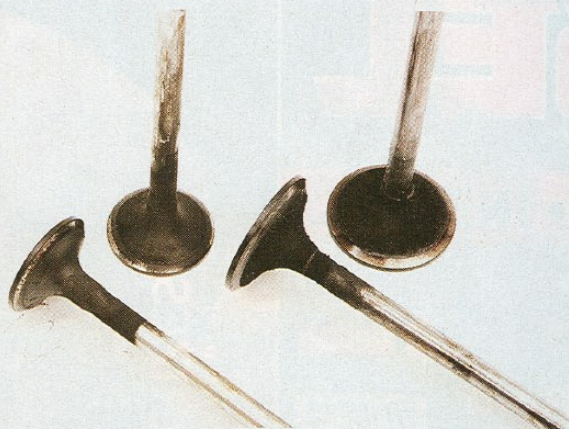
**11.** The valves had a fair amount of soot built up, but were in otherwise good condition.

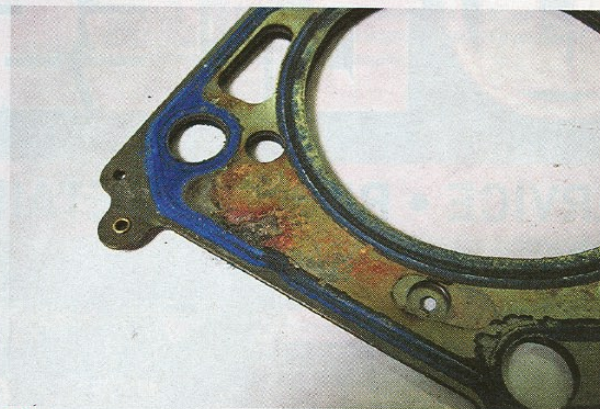
**13.** There was one portion of the head gasket that had begun to show progress toward leaking, but this gasket never actually gave way.

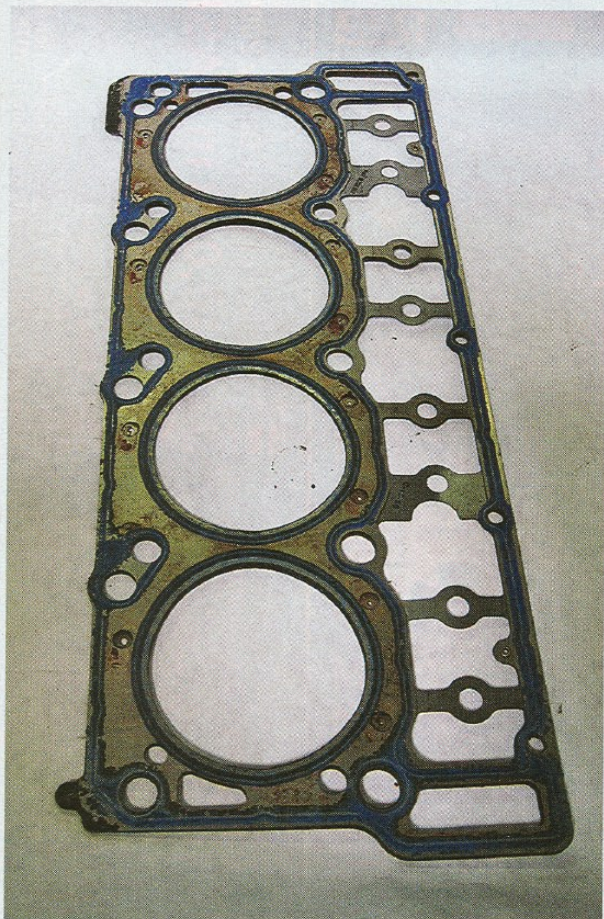
**12.** The head gasket was actually in relatively good condition, and clearly not a factor in the engine's failure.

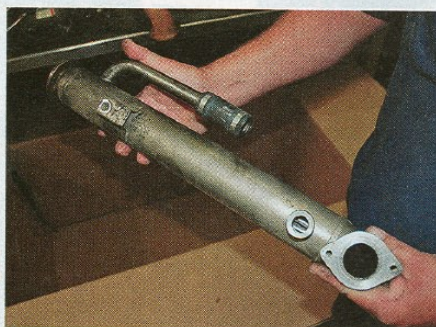
**14.** The EGR mechanism on early 6.0L engines was a source of a multitude of problems. A Ford service bulletin noted carbon deposits on the EGR valve could lead to turbo vane sticking, plug the MAP sensor hose, and even allow moisture to attack other problems. EGR cooler

leaks were so common on early engines that a new EGR cooler was designed, and mechanics were advised to replace the old units with the newly designed part upon rebuild. One mechanic told us that the leaking EGR units caused more head gasket failures than the supposedly inadequate head bolts. In this case, the EGR tube was indeed sooty, but there was no evidence it had created any problems.

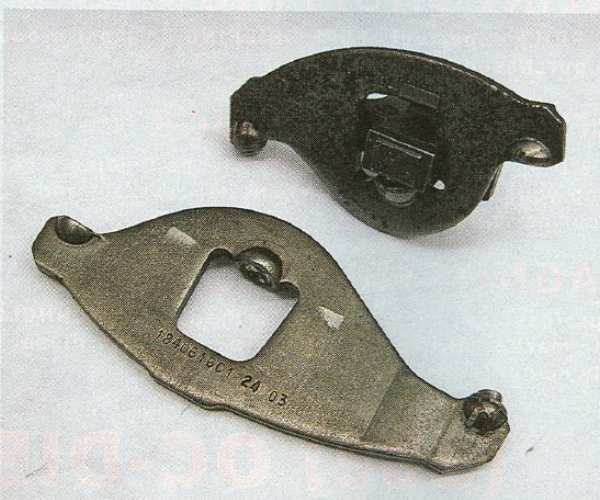
**15.** A close look at the rocker arms showed some corrosion and slight galling.

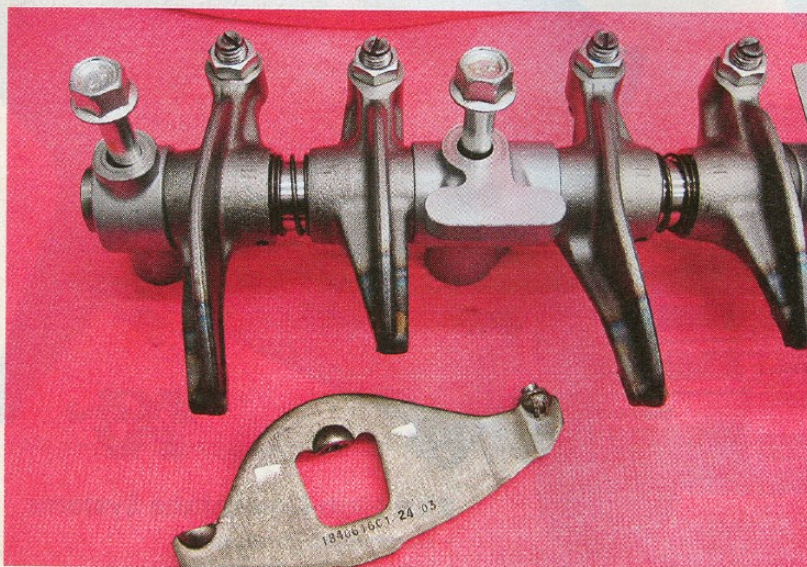
**16.** From a design point of view, the Ford/Navistar 6.0 Rockers are not tremendously impressive pieces. Here one of the 6.0 rockers is compared to the rocker set from a Duramax, which have more material and a stronger design.

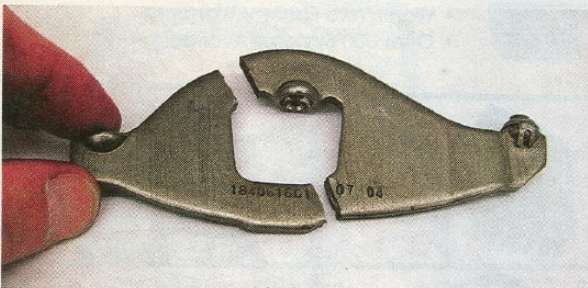
**17.** Sure enough, the culprit in this particular engine was a rocker that snapped in half. Upon rebuild, all will be replaced with new Ford parts, as no high-performance rockers are available yet for the 6.0.

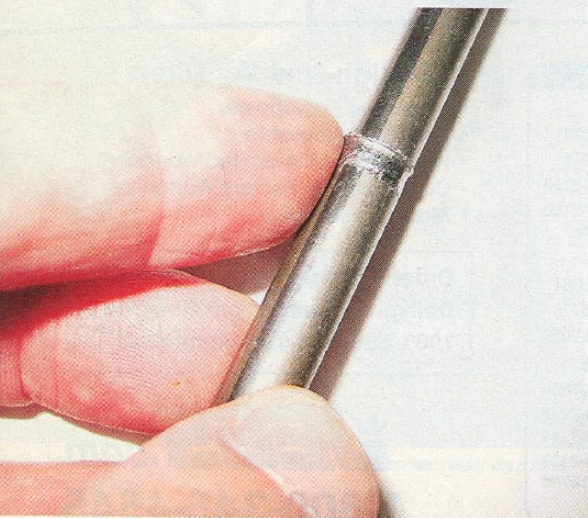
**18.** The pushrods were all unbent and without undue wear, so they can be reused. The one exception was a rod that had a ring gouged around the circumference, possibly at the time the rocker arm failed. It will be replaced with a new pushrod.

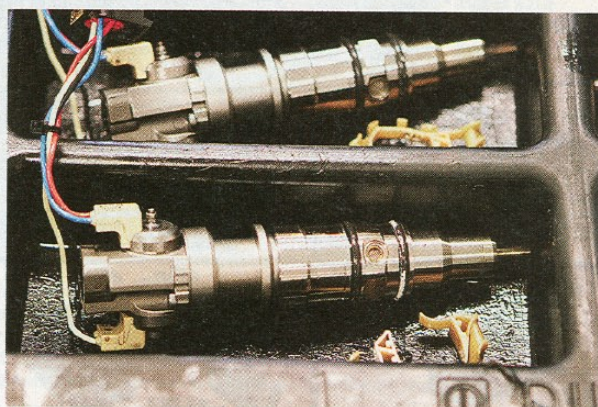
**19.** Our injectors looked reasonably good, with no unusual patterns of soot or burning that might indicate blow-by from failed O-rings or seals. All eight were sent out to an injector specialist for testing. The turbocharger, likewise, appeared to be in good condition, but it was sent to a turbo specialist for examination and possible reconditioning. We'll have word on both components in our next installment, along with porting and rebuilding the heads.
