INSIDE FORD'S ALL-NEW 6.7L SCORPION DIESEL

PERFORMANCE REBUILD: FORD/NAVISTAR 6.0

Part 3: Cylinder Head Installation With ARP Studs

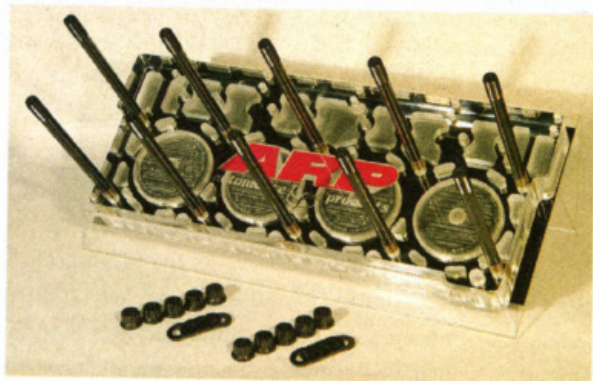
ARP cylinder head stud kits come with washers and 12-point nuts, and a black-oxide finish that protects them from wear and corrosion.

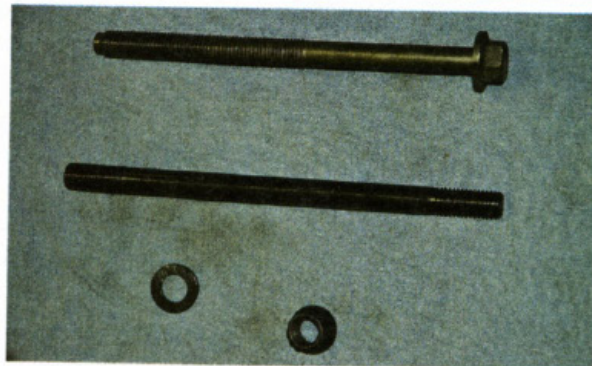
The standard Ford/IH head bolts are known as torque-to-limit bolts. They are designed to stretch when tightened to a specific torque limit, and cannot be reused. At bottom is an ARP stud, with washer and retaining nut.

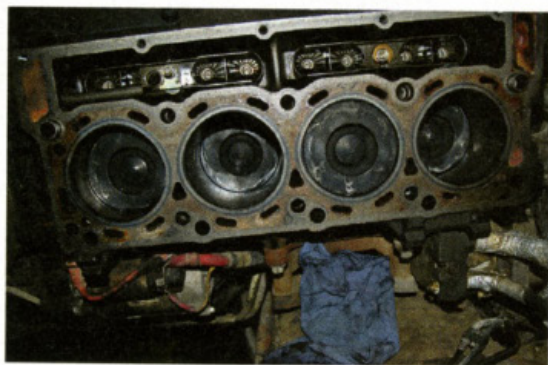
1. This is what the left side of our 6.0 looked like after the heads and gaskets were removed.

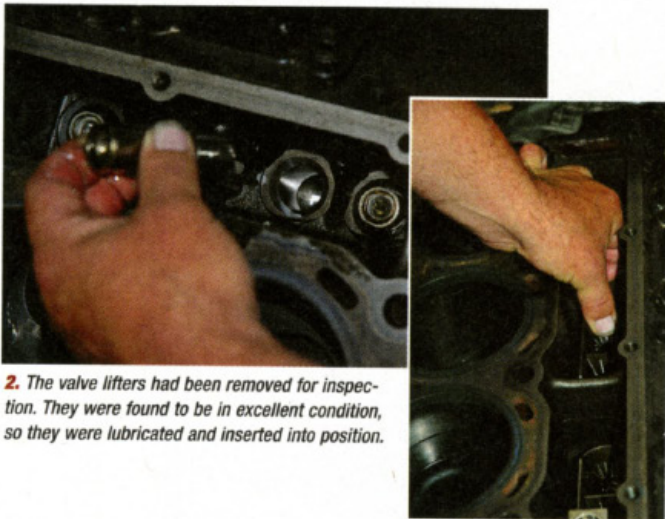
2. The valve lifters had been removed for inspection. They were found to be in excellent condition, so they were lubricated and inserted into position.

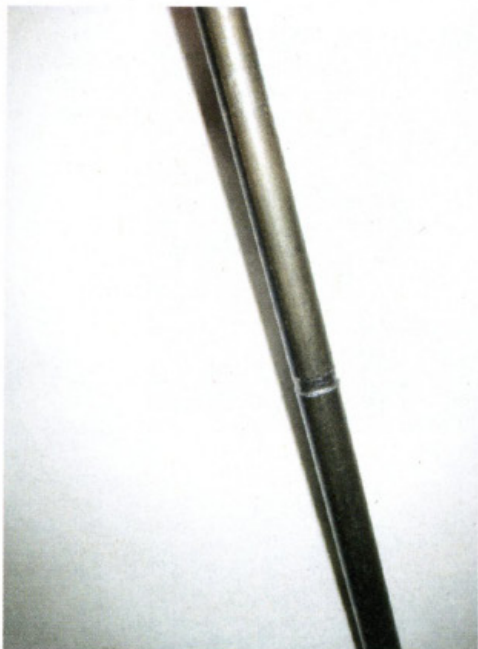
pushrods were all measured for length and found to be within specification with the exception of one rod that had been gouged after the rocker arm failure, which then had to be replaced with a new Ford rod.

13. The pushrods were all the right length and showed very little wear, with the exception of this one, which was badly galled and had to be replaced.
