## FORD POWER STROKE 6.0L

### Part 1: What Fails and Why

**2.** This is our project truck, an '03 F-350 4x4 dualy. The rig didn't have a whole lot of miles, but judging by the mud under the body, it had seen some hard use. Once in the Banks workshop, the first challenge was just to get at the engine.

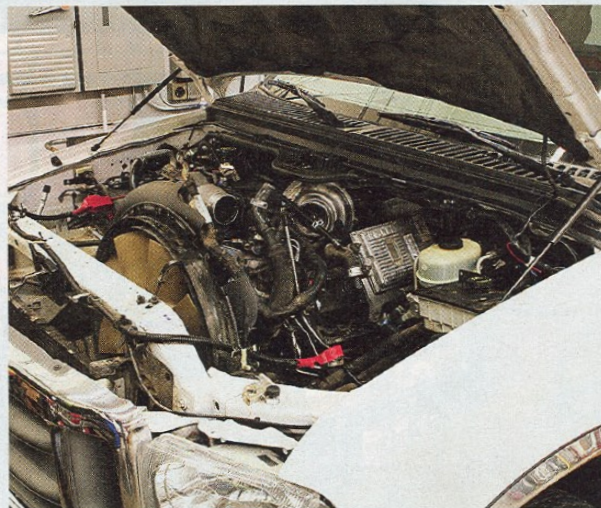
**4.** A few hours later, a few engine pieces become visible, but access to the turbo and heads is still a long way off. Ultimately, it became obvious that the body would best be lifted from the chassis to get at the engine. While we're told that it is actually possible to do top-end work on the 6.0 with the body in place, it requires special tools and burns a lot of time.

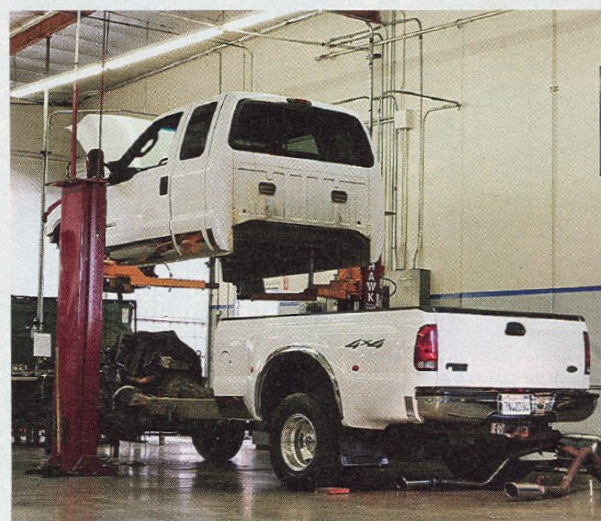
**5.** To get the cab off the frame involved undoing six rusty body mount bolts, unplugging every connector in sight, and undoing the front brake lines, the throttle cable, ABS plugs, emergency brake cable; removing the exhaust system, oil/transmission cooler lines, fuel lines, steering shaft from the steering box...whew... evacuating the R134 coolant from the A/C system and removing the lines, draining the cooling system and removing the radiator, intercooler and fan shroud...whew...then gingerly moving the body upward slightly to find out what was still attached. Which might include the antilock controller and any of half a dozen plugs that connect the cab to the engine or transmission. The process took an experienced mechanic, working in a highly organized professional environment with power tools and a lift, the better part of a full day.

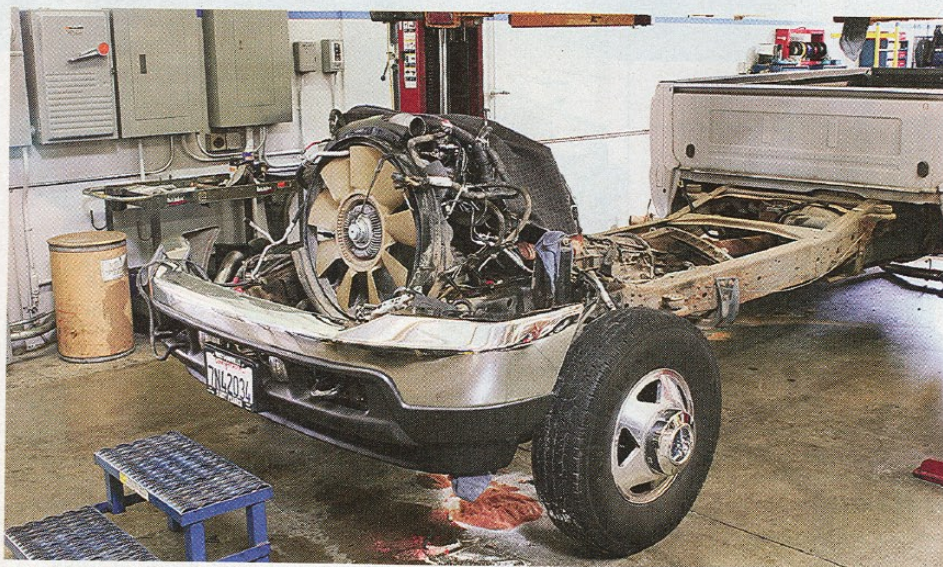
**6.** With the body separated from the frame, work could begin getting the huge engine fan and EGR pieces off the engine.

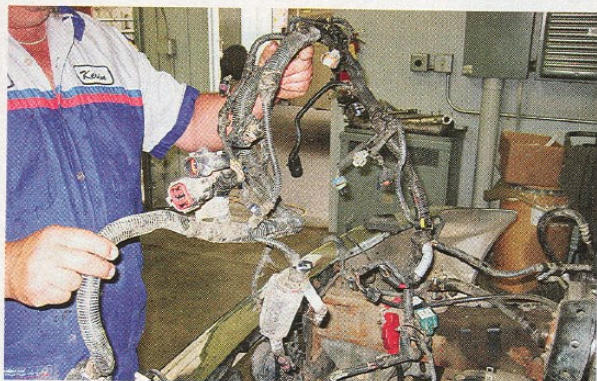
**7.** Not to put too fine a point on it, but engines these days have just slightly less wiring than the space shuttle. This is the kind of spaghetti you'll be dealing with when you finally get to the engine. Budget another eight hours to remate engine to cab once the rebuild is done.

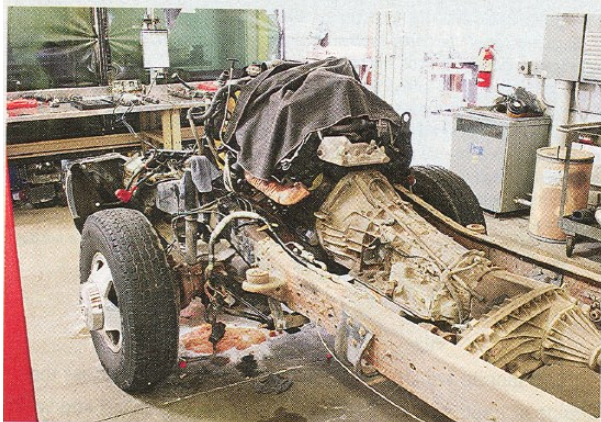
**8.** However, now that everything is cleared away, engine disassembly can progress at a rapid pace.

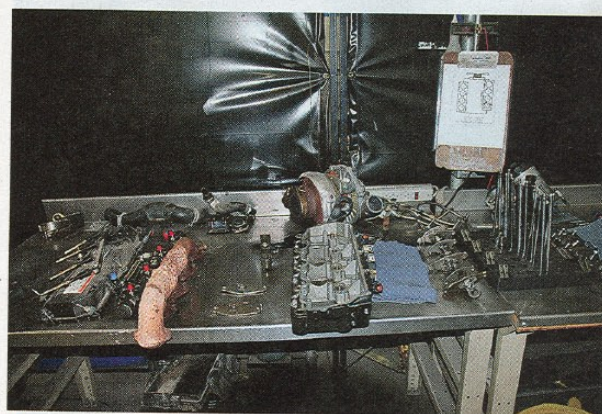
**9.** Here we see the disassembled engine parts. The heads were taken to the clean room at Banks Performance for inspection. Injectors and turbo will be sent out for evaluation.
